# TREATMENT PLAN FOR BALBOA PARK BOTANICAL GARDENS SAN DIEGO, SAN DIEGO COUNTY, CALIFORNIA

March 2024  
PN 45150

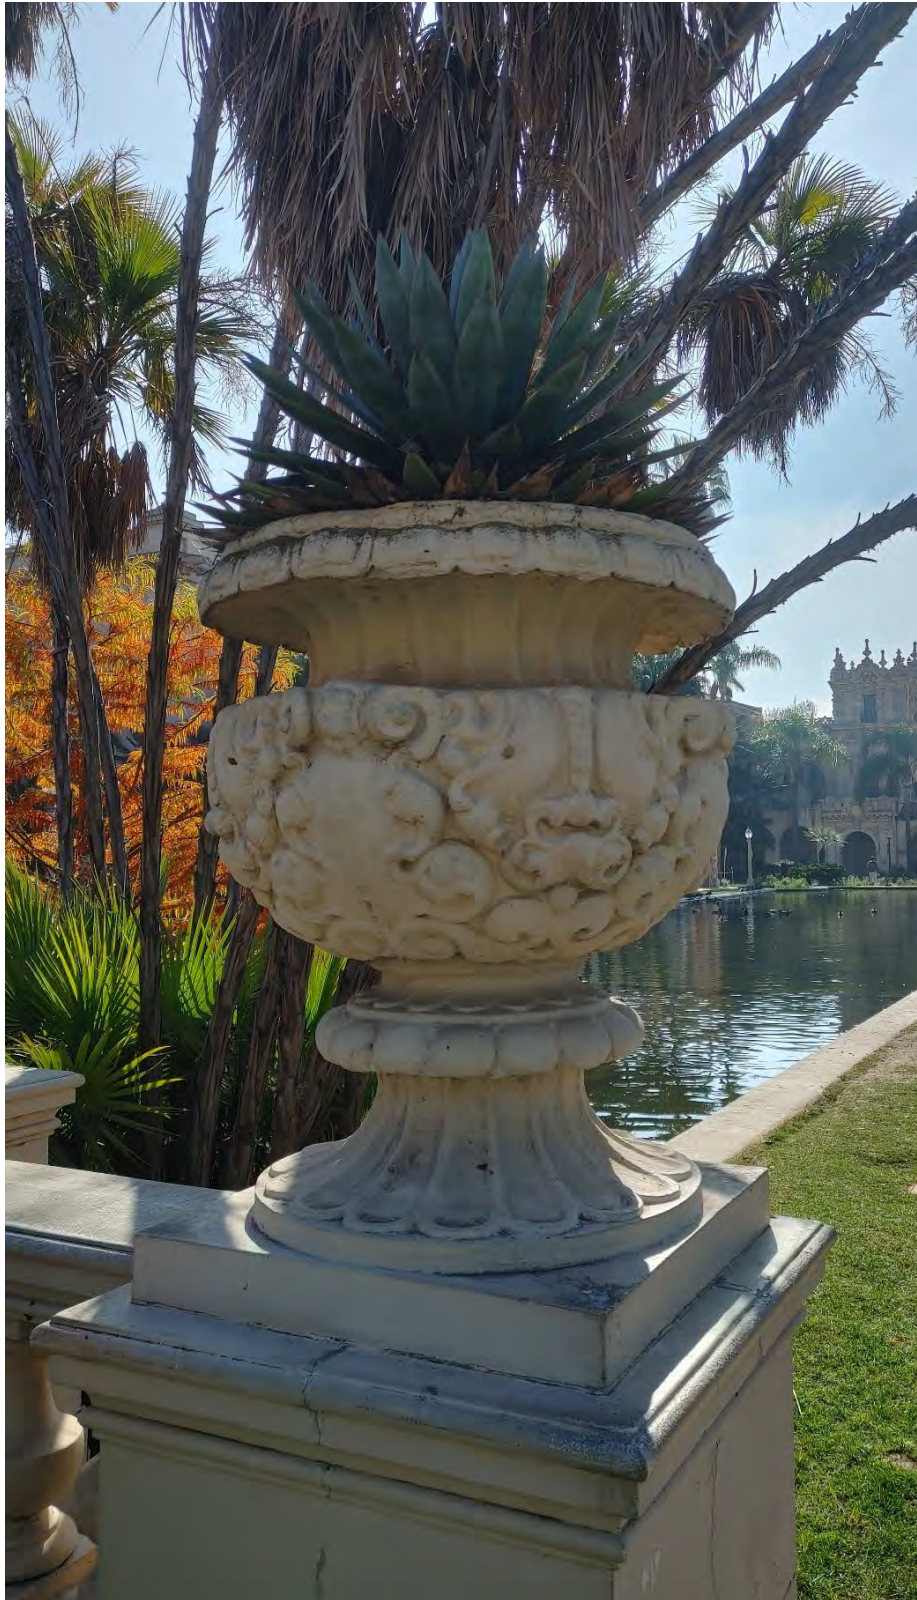
Figure 28. Urn atop structurally damaged southwestern pedestal, facing southeast. Photo credit: Elizabeth Herlihy.

The pedestal of the southwestern urn on the south balustrade has a structural crack that will require reconstruction and is therefore the recommended location for deconstructive testing to determine the composition of the 1960s concrete mix for the urn and balustrade. The testing should also determine if the pedestals are solid or a hollow box. The reconstructed pedestal shall match the original in form, design, and materials, based on the evidence of the extant pedestals.

impractical. Such is the case with the pedestal of the urn with a structural crack. In instances in which sufficient form and detailing still exist to re-establish the feature as an integral part of the rehabilitation project, then its replacement is appropriate. Replacement of the entire feature in kind, that is, with the same material, is always the preferred option. It should be noted that, while the NPS guidelines recommend the replacement of an entire character-defining feature under certain well-defined circumstances, they never recommend removal and replacement with new material of a feature that—although damaged or deteriorated—could reasonably be repaired and thus preserved.

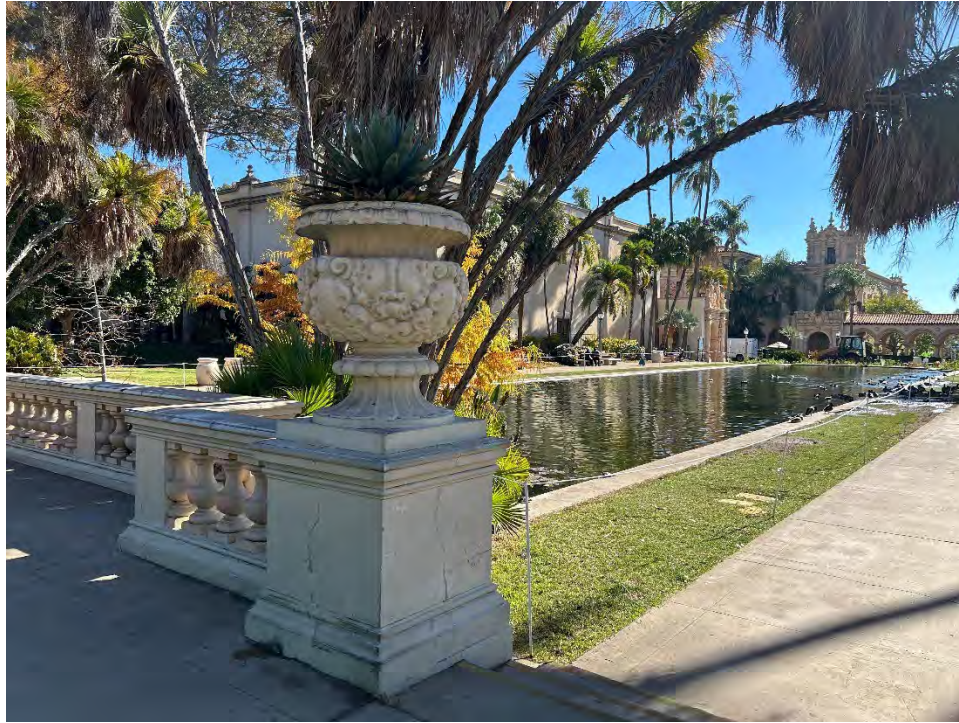
Figure 33. Southern balustrade and urn with structurally deficient pedestal, view toward Laguna de Las Flores, facing southeast. Photo credit: Sarah Stringer-Bowsher.

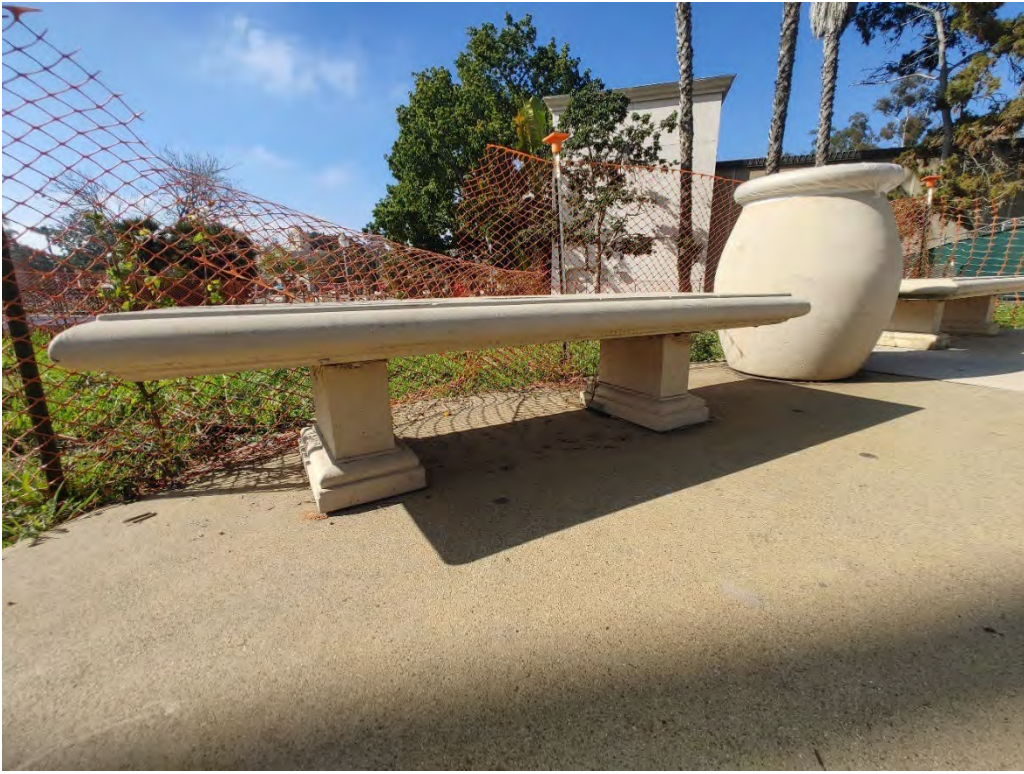
The historical record confirms that the Laguna de Las Flores was originally lined with many more rectangular benches than exist today and those extant today are not original benches. Originally the fountains were surrounded by curved benches, replaced at some point with rectangular benches (Figure 37). These were originally concrete and appear to have been the same shade of white as the balustrades (although the exact shade of white is not identified). The benches were removed at some unknown date and replaced by fewer concrete benches of a slightly different design.

Figure 37. Bench near west fountain, facing west.

The missing benches will be replaced/constructed following a design which can be substantiated by documentary evidence to restore the historic spatial relationships that previously characterized the property. Both the three-footed rectangular and five-footed curved benches will be reconstructed; four round benches surrounding each fountain (a total of eight) and 27 rectangular benches distributed on both sides of the Laguna de Las Flores. A special formwork will be designed to recreate the curved benches, whereas a form has already been created for the rectangular benches, recently reconstructed for Alcazar Garden (Figures 38-39), another area within the Balboa Park historic district. One alteration to the design of the original benches will be a small engraved, concrete band under the seat of the bench, used for donor recognition (Figures 38-39). The addition of these plaques will comply with the *Standards* as they shall be differentiated from the design of the reconstructed benches yet compatible with the historic materials, features, size, scale and proportion, and massing.
